ASR Induced Blow-up in an Urban Concrete Pavement (Bahía Blanca–Argentina)

The urban pavement at 600 Catamarca street in the city of Bahía Blanca (Argentina) burst lifting the concrete slabs at the contraction joint. The aim of this study was to investigate the causes that lead to the concrete deterioration. Aggregate constituent materials, their mineralogy, textures, condition of the paste and the aggregate–mortar interface were determined by a petrographic analysis of the concrete. A petrographic optical microscope, X-ray diffraction (XRD), scanning electron microscope (SEM) and energy dispersive X-ray (EDX) was used. Abundant ettringite development was noted both inside cavities and on the concrete surface. Its occurrence was confirmed by XRD and EDX analyzes. The aggregate deleterious constituents were mainly glassy vulcanites and volcanic glass, generally altered to argillaceous minerals of the montmorillonite group and strained quartz, with undulatory extinction. It was concluded that pavement deterioration was due to the alkali–silica reaction (ASR).

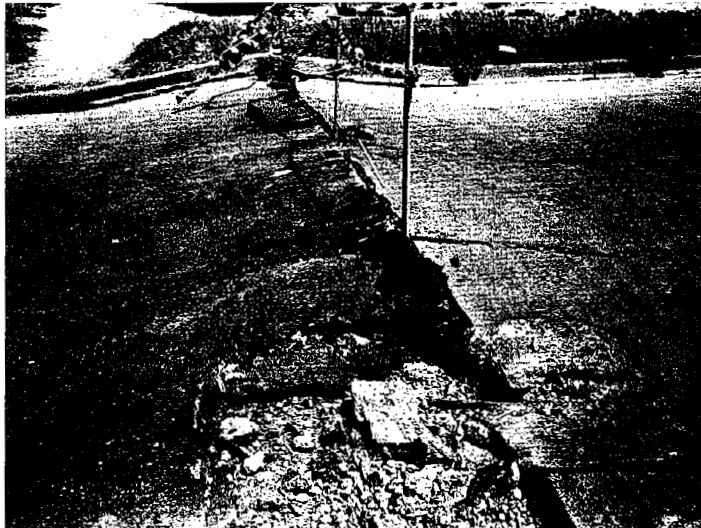
A survey of the affected area was conducted, showing that nearby contraction joints were tightly closed with bitumen draining from them.

FIGURE 1 View of the deteriorated pavement at 600 Catamarca street, after the burst.

Slabs were lifted over 0.3 m and dislodged from the ground, causing extensive cracking that led to the displacement of large fragments of material. The condition of the pavement is shown in Fig. 1.

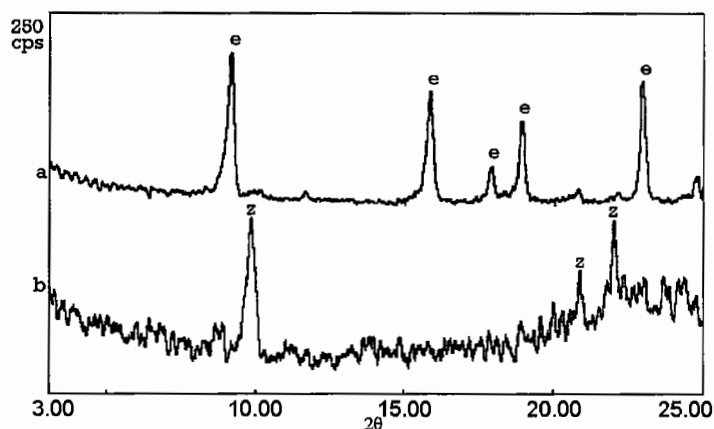
The material from inside the cracks, reaction rims and surfaces of the reactive aggregates was analyzed by XRD. A zeolite of the clinoptilolite–heulandite ($\text{KNa}_2\text{Ca}_2(\text{Si}_{29}\text{Al}_7)\text{O}_{72}\cdot 24\text{H}_2\text{O}$), (ICDD 39-1383) group was identified as the reaction product (Fig. 4(a)). This material presented the highest intensity of reflection at 8.9 \AA and could be easily discriminated from ettringite ($\text{Ca}_6\text{Al}_2(\text{SO}_4)_3(\text{OH})_{12}\cdot 26\text{H}_2\text{O}$), which had the characteristic reflection at 9.7 \AA , as shown in Fig. 4(b). The latter occurred mainly inside cavities of air voids and on the deteriorated concrete surface.

FIGURE 4 XRD of the reaction products. (a) Ettringite (e). (b) Zeolite (z). Their spectra show clear differences.

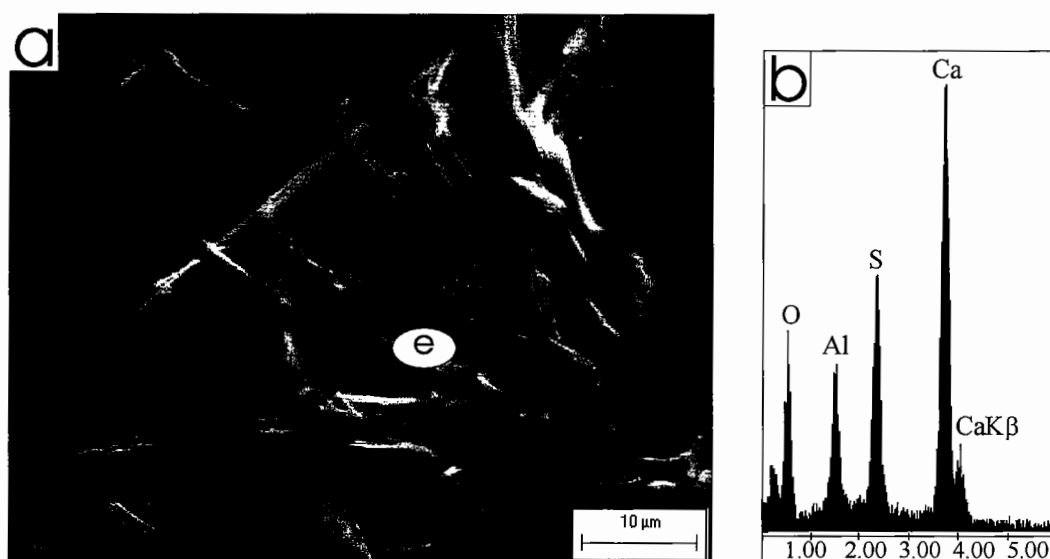
An analysis of the fibrous material identified as ettringite by XRD was performed. The morphology of

the crystals is shown in Fig. 5(a). The EDX analysis (Fig. 5(b)) revealed the presence of S, Al, O and Ca, in proportions attributed to be ettringite.

FIGURE 5 (a) Fibrous crystals that developed in the deteriorated concrete, identified as ettringite (e) by XRD. (b) EDAX of the material shown in 5(a).

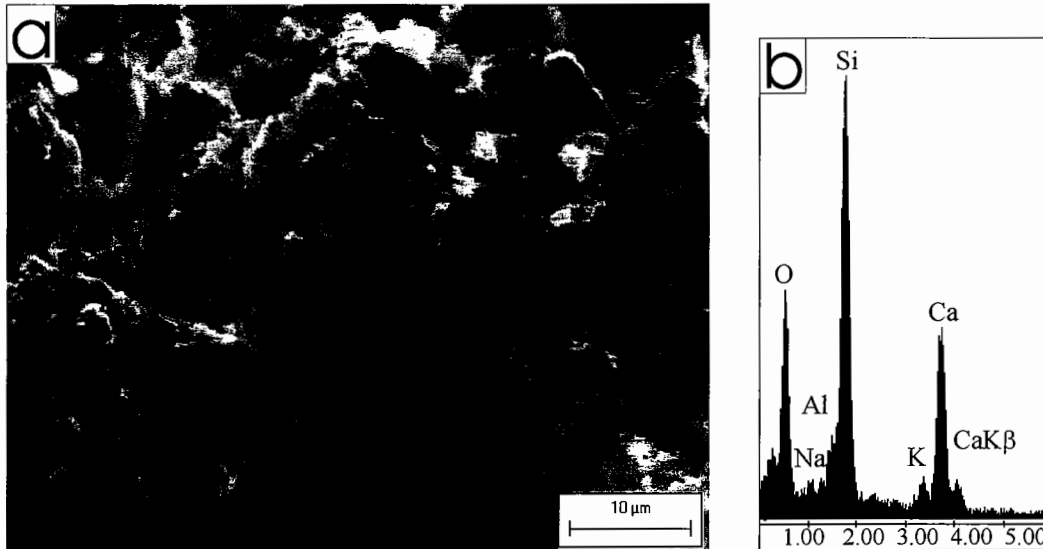
Figure 6(a) illustrates the reaction product from the deleterious aggregates. It developed as reaction rims and inside microcracks. Figure 6(b) gives its chemical composition determined by EDX (Si, Al, O, Ca, Na and K), which was attributed to zeolite identified as clinoptilolite by XRD.

FIGURE 6 (a) Reaction product that developed from the reactive aggregates, identified as clinoptilolite by XRD. (b) EDAX of the material shown in (a).
